Re: July 2014 Monthly Progress Report
Administrative Settlement Agreement and Order on Consent for Removal Action
U.S. EPA Region 10 Docket No. CERCLA 10-2009-0255
Gasco Sediments Site within the Portland Harbor Superfund Site

Visual Observations Log Form

Monitoring Period: Monthly (Year 8)—July 2014

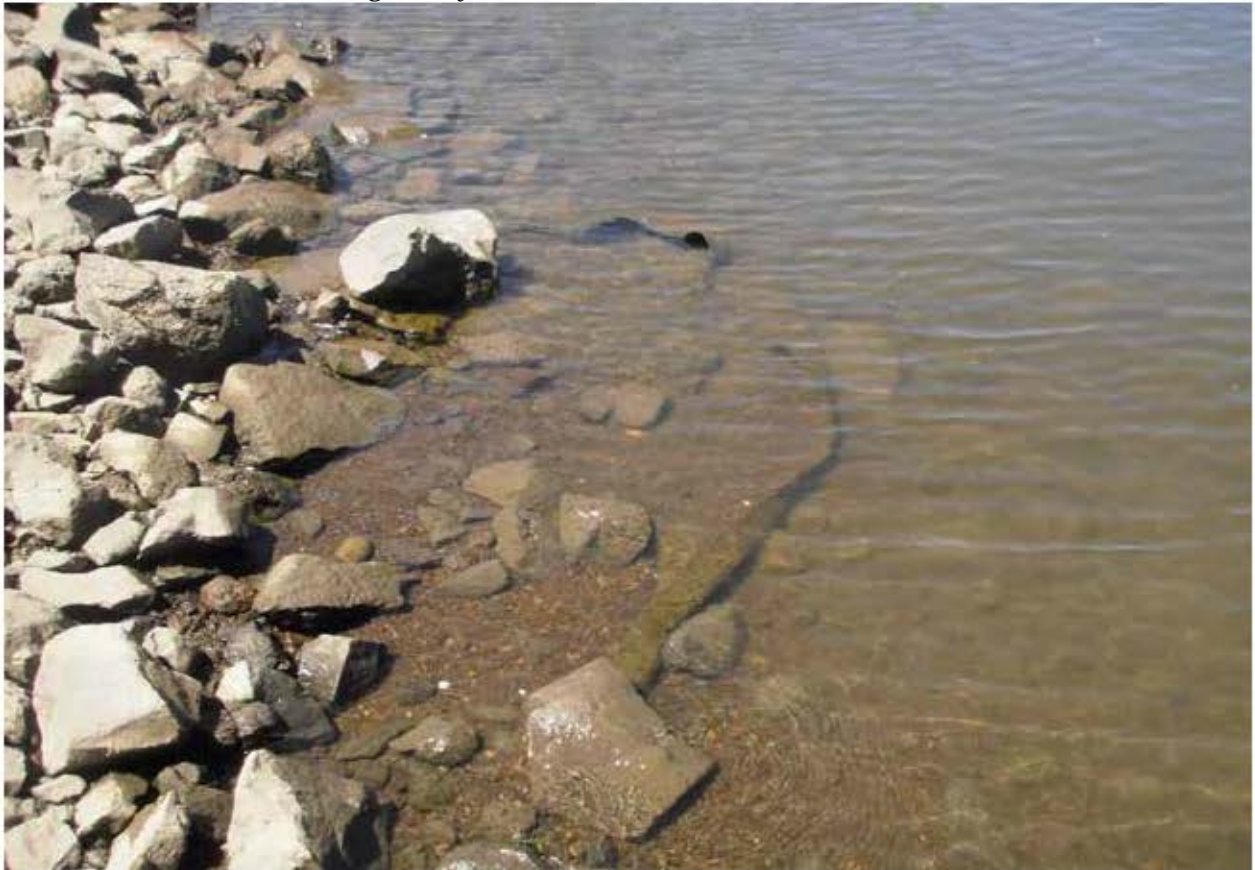
Observations of Erosion/Deposition: No erosion/deposition is evident along the shoreline. Two organoclay mat material segments are visible in the river. A segment measuring 5-foot in length is submerged beneath 0.5 to 1.0 feet of water near the lateral mid-point of the cap area (Photo 1). A 15-foot width of organoclay mat material is visible and submerged beneath 2 to 3 feet of water near the downriver extent of the cap.

Photo 1— *Visible section of organoclay mat material (7/16/14):*

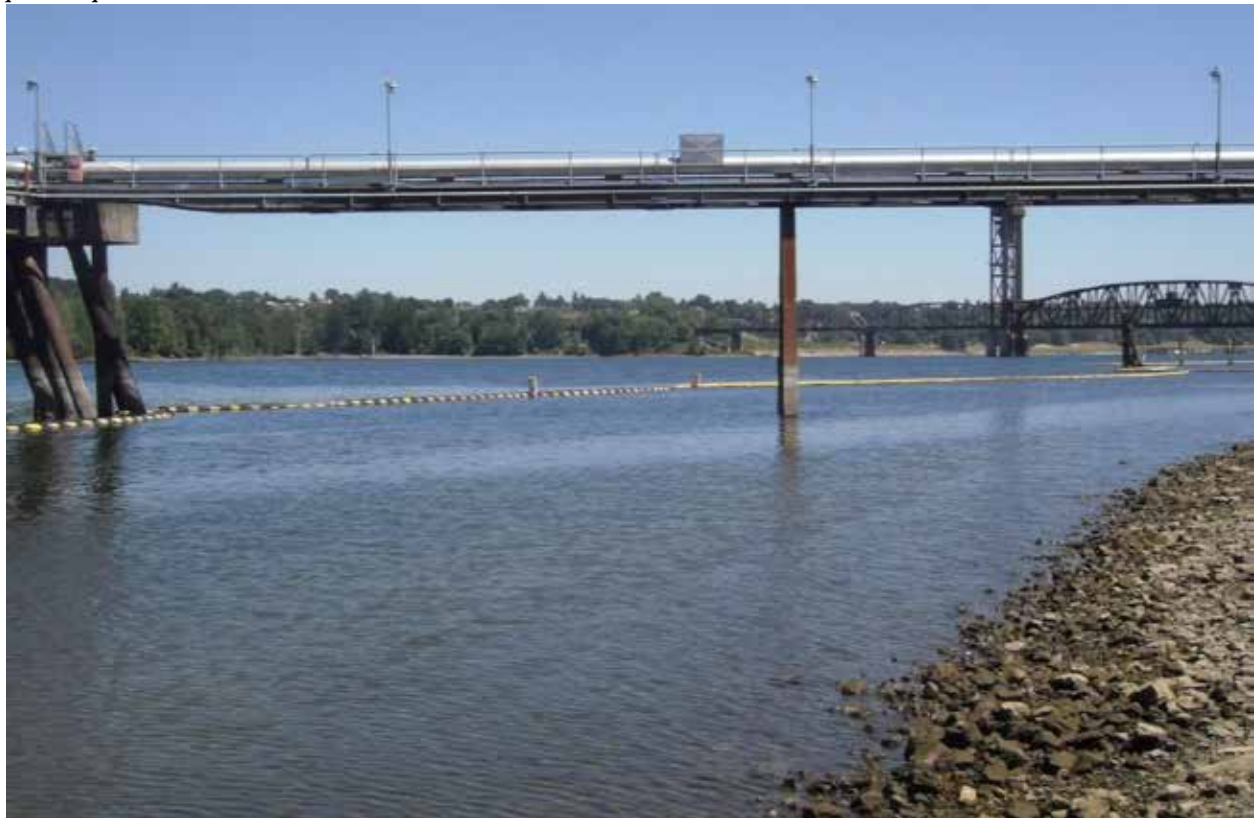
Observations of Long-term Controls (i.e., oil booms, organo-clay mat, etc.) During the observation, the Fuel and Marine Marketing (FAMM) containment boom was in place across the cap area, between the upriver corner of the ship dock and the wooden dolphin (near the upriver extent of the site and near the Siltronic Corporation outfall). Buoys that identify the cap area to mariners are in place. The position of the FAMM oil boom, warning buoys, and a general overview of the site shoreline is shown in Photo 2.

Photo 2 — *FAMM oil boom shown from dock to dolphin and mariner warning buoys in place across pilot cap area. (7/16/14):*

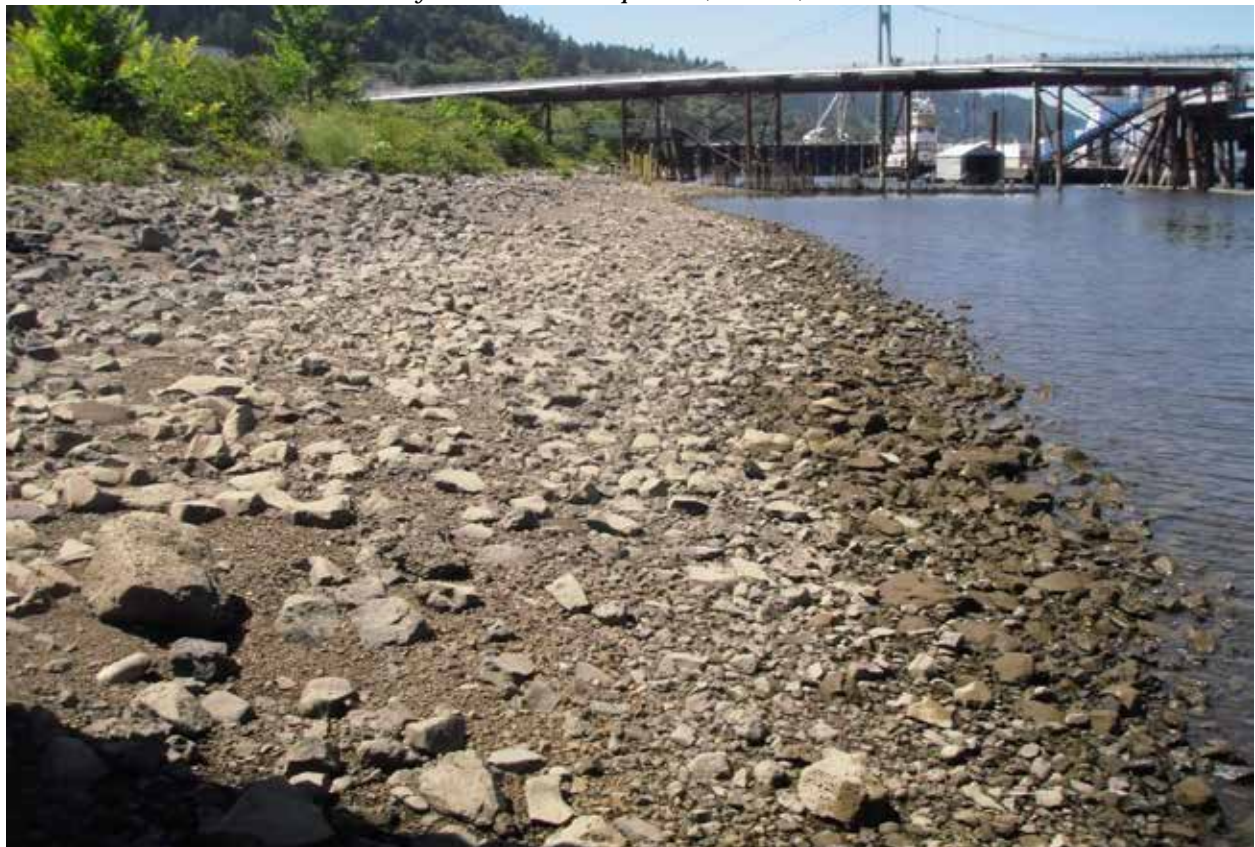
No sheen is evident in or around the cap area. Photo 3 shows the water surface and shoreline immediately downriver of the sediment cap.

Photo 3 — *Conditions immediately downriver of cap area (7/16/14):*
